South Harbour Condominium
751 Pensacola Beach Blvd.
Pensacola, FL 32561

Regarding: **South Harbour Condominium – Phase I Milestone Inspection**

**South Harbour Condominium
Appendix B – Photo Log
Site Visit Date: 03/27/24**

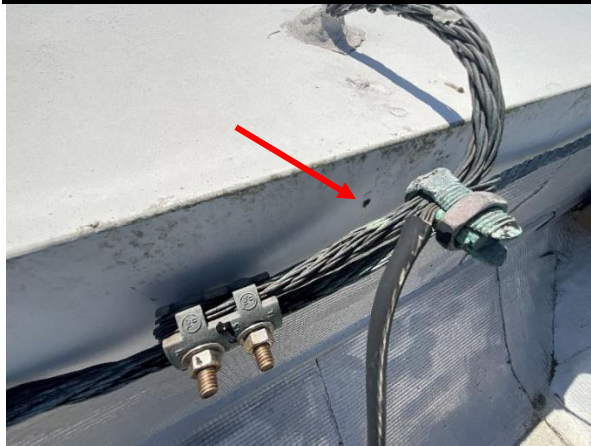
3.2.1 BECI observed isolated voids along the metal coping to roof membrane of the main roof where the surge protection had previously connected. ***BECI recommends hiring a licensed Florida contractor to repair the voids along the main roof perimeter within the next year.*** This will help prevent water intrusion through these voids and into the building envelope. (Reference Photo Exhibit Nos. 1 and 2).

Photo 1
Roof – View of isolated fastener holes at surge protection – Isolated.

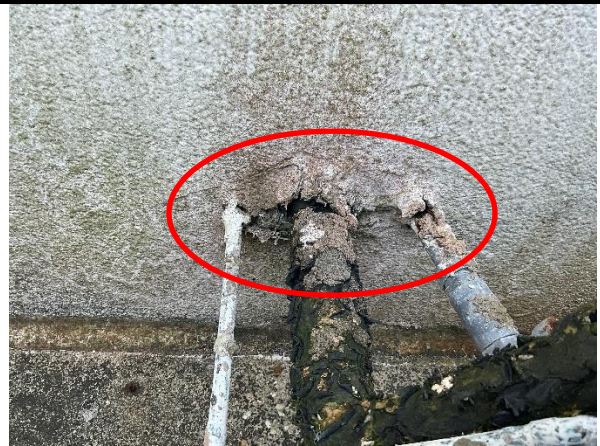
3.2.2 BECI observed isolated locations of unsealed wall penetrations and uncoated exterior cladding on the North and South Elevations of the building. ***BECI recommends that the isolated locations of unsealed wall penetrations be sealed and the exterior cladding be coated by a licensed Florida contractor within the next year.*** This will help prevent further stucco deterioration, damage, and possible moisture intrusion into interior framing members. (Reference Photo Exhibit Nos. 3 through 6).

Photo 4
North Elevation – View of failed sealant at wall penetration – Isolated.

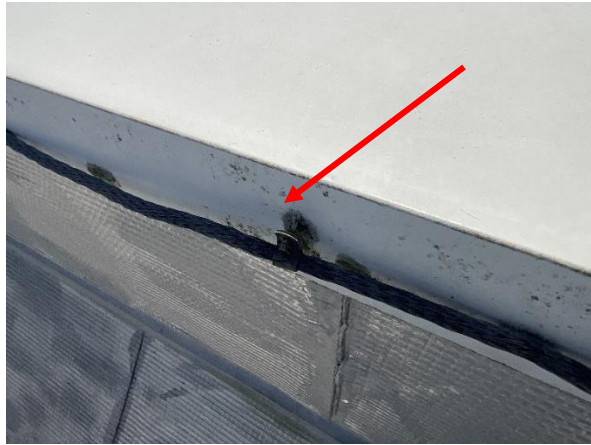
Photo 2
Roof – View of isolated fastener holes at surge protection – Isolated.

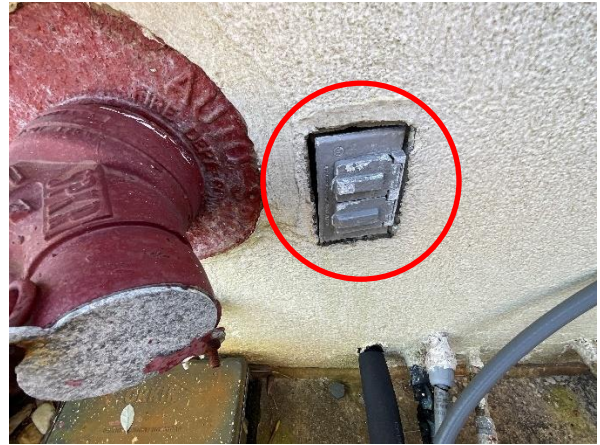
Photo 5
North Elevation – View of failed sealant at wall penetration – Isolated.

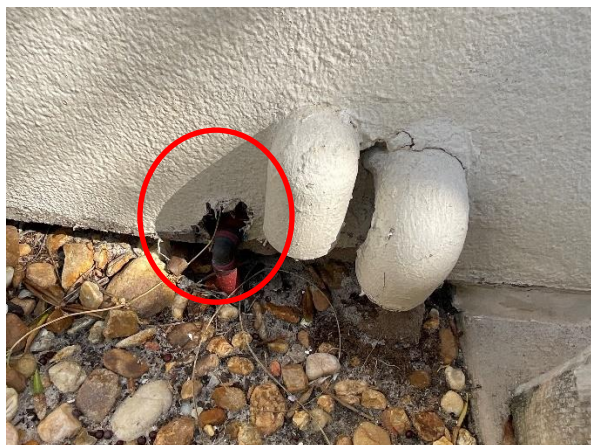
Photo 3
South Elevation – View of failed sealant at wall penetration – Isolated.

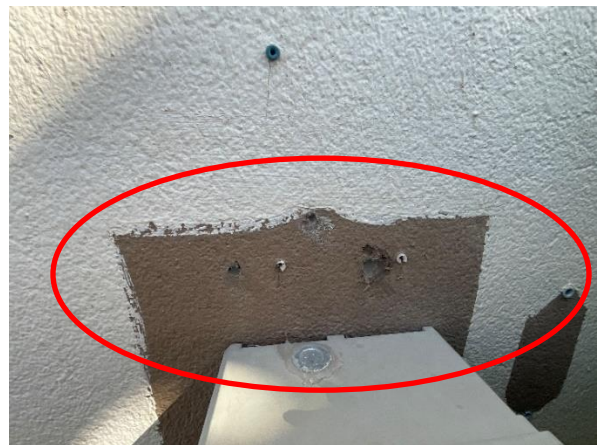
Photo 6
South Elevation – View of unpainted cladding unsealed abandoned fastener holes – Isolated.

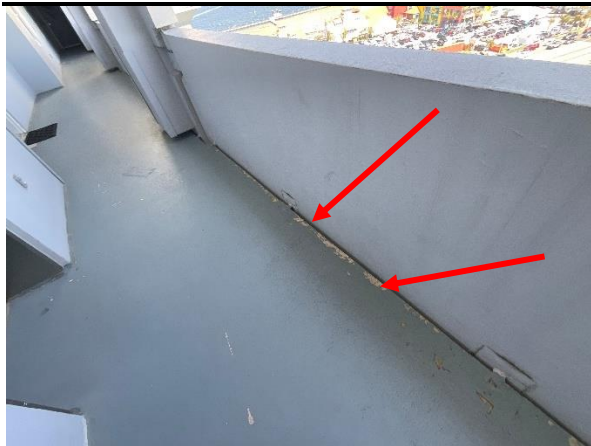
- 3.2.3 BECI also observed widespread deck coating failure on the common walkways of the East Elevation and private balcony decks of the West Elevation. Additionally, we noted typically uncoated spall repairs at the private balcony decks. **Per the scope of work submitted to the board by BECI on March 28, 2024, BECI recommends replacing the deck coating system at the common walkways. Additionally, we recommend that consideration be given to replacing the deck coating system at the private balcony decks.** This will ensure the protection of the deck and balcony components below. (Reference Photo Exhibit Nos. 7 through 11).

Photo 7
East Elevation – Common Walkways – Floor 12 -
Overall View of failed coating at concrete deck –
Typical.

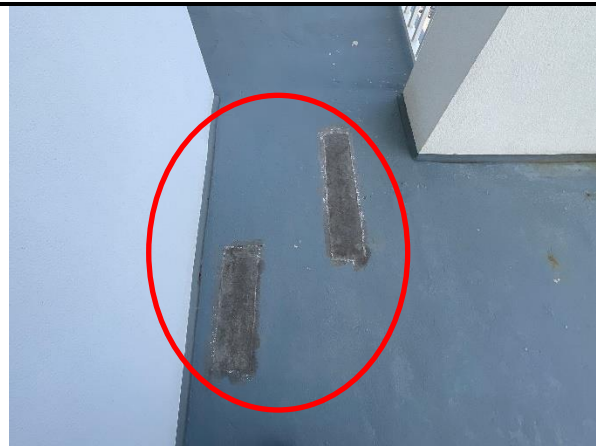
Photo 10
West Elevation – Private Balconies – Floor 13 –
View of uncoated spall repairs on balcony deck –
Typical.

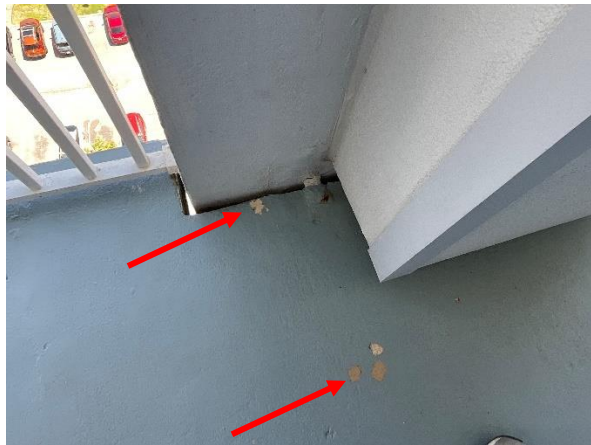
Photo 8
East Elevation – Common Walkways – Floor 11 -
Overall View of failed coating at concrete deck –
Typical.

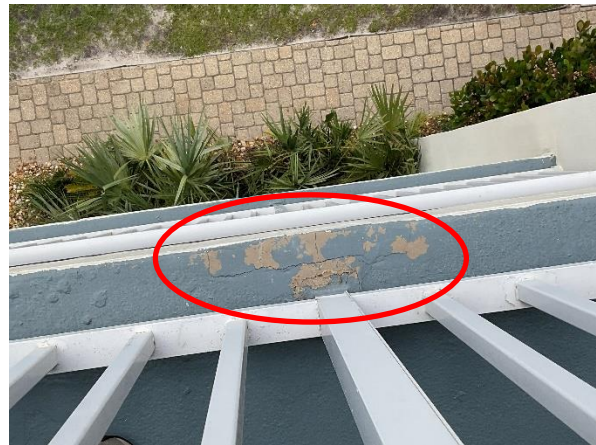
Photo 11
West Elevation – Private Balconies – Floor 3 –
View of failed coating at concrete deck – Typical.

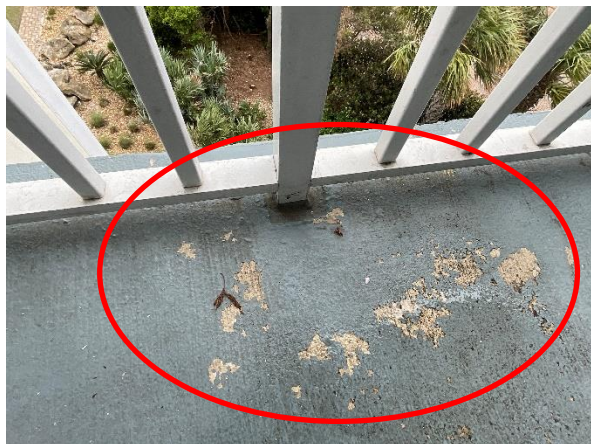
Photo 9
West Elevation – Private Balconies – Floor 4 –
View of failed coating at concrete deck – Typical.

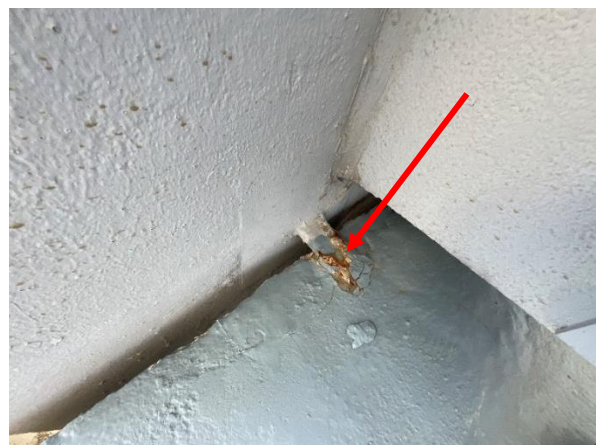
- 3.2.4 Additionally at the East Elevation, BECI typically observed corroded knee wall tabs in the common walkways. **Per the scope of work submitted to the board by BECI on March 28, 2024, BECI recommends to repair the knee wall tabs when the existing coatings are removed. The surface corrosion should be mechanically cleaned with a hand-wire brush or mechanical wire wheel. If a knee wall is broken or cracked, it should be welded in place. Any tabs that have lost 25% of their weight or dimensions should be replaced.** If knee wall tabs are left untreated and unreplaced, the knee walls of the common walkways could begin to deteriorate further, jeopardizing the security of the concrete knee wall. (Reference Photo Exhibit Nos. 12 and 13).

Photo 12
East Elevation – Common Walkways – Floor 5 –
View of corroded knee wall tab – Typical.

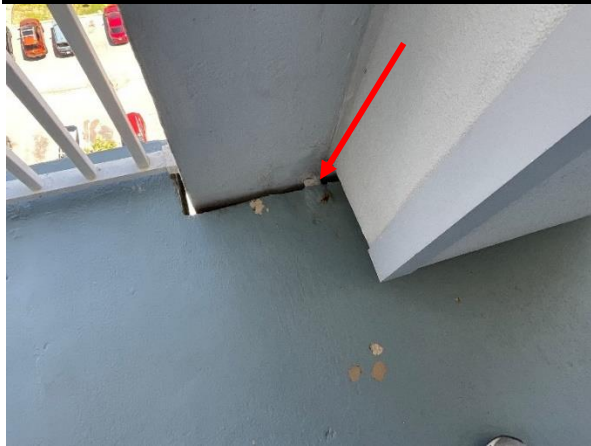
Photo 13
East Elevation – Common Walkways – Floor 11 –
View of corroded knee wall tab – Typical.

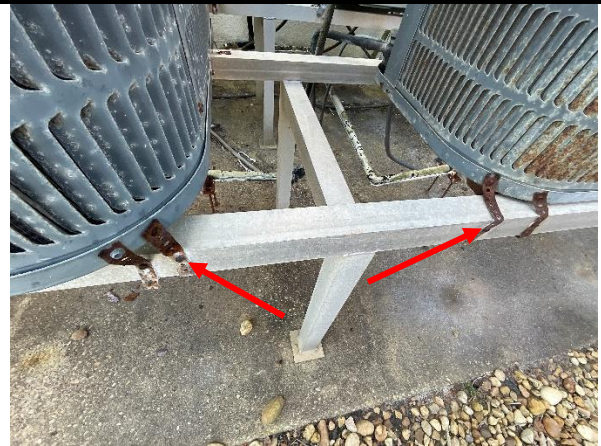
- 3.2.6 BECI observed a typical condition of missing and corroded hurricane straps at the main roof HVAC units and the South and North Elevation HVAC units. **BECI recommends that the corroded and missing hurricane straps be removed and replaced by a licensed Florida contractor as soon as possible.** This will help secure the HVAC units from strong winds (Reference Photo Exhibit Nos. 15 through 18).

Photo 16
North Elevation – View of corroded hurricane
straps – Typical.

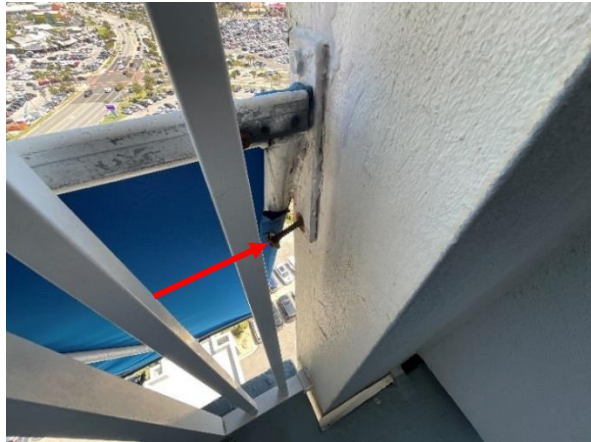
- 3.2.5 BECI also observed isolated corroded and loose fasteners at the third railing section from Southmost railing section on the Penthouse Floor awning. **BECI recommends replacing these fasteners to secure the awning at this location as soon as possible.** If the fasteners are left unreplaced, it could jeopardize the security of the awning (Reference Photo Exhibit No. 14).

Photo 14
East Elevation – Common Walkways –
Penthouse Floor – View of loose and corroded
fasteners – Isolated.

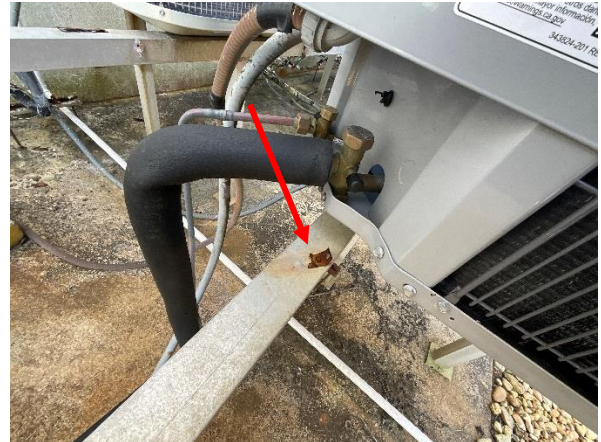
Photo 17
North Elevation – View of corroded and broken
hurricane strap – Typical.

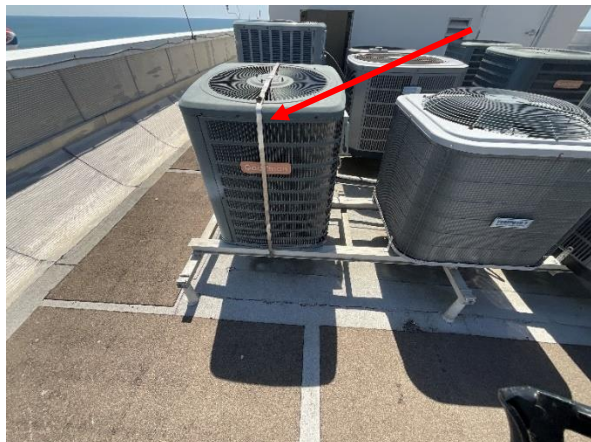
Photo 15
Roof – View of HVAC unit with poor support and
no hurricane straps – Isolated.

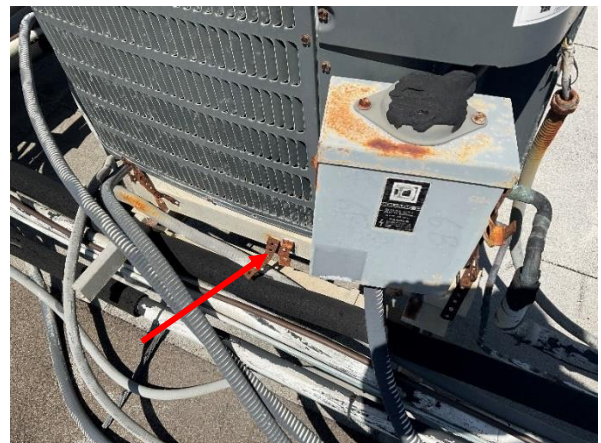
Photo 18
Roof – View of corroded hurricane straps at
HVAC units – Typical.

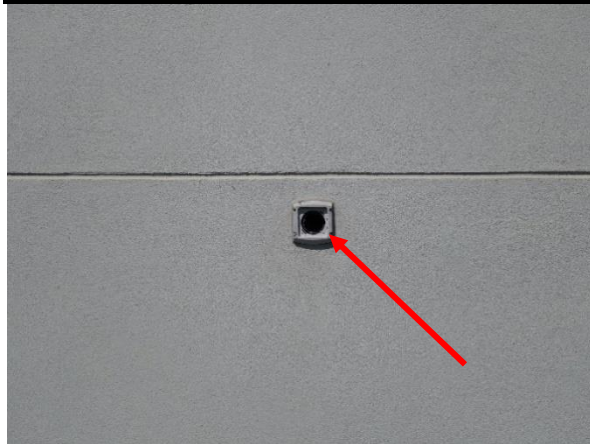
- 3.2.7 BECI also observed damaged and exposed dryer vents on the North and South Elevations. **BECI recommends considering changing the location of the dryer vents to the common walkways so that they are more easily serviceable. After the dryer vents have been moved, we recommend sealing the openings.** The current condition of the dryer vents makes them more readily susceptible to lint and debris buildup in the dryer vents due to the difficulty of access to service. (Reference Photo Exhibit Nos. 19 and 20).

Photo 19
South Elevation – View of broken dryer vent – Typical.

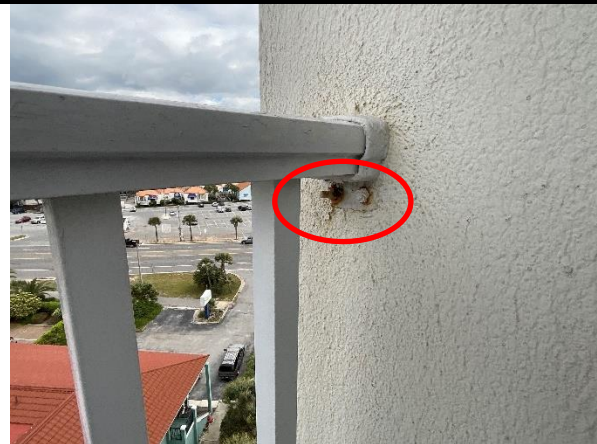
- 3.2.8 At the West Elevation private balconies, BECI observed several isolated corroded fasteners. Additionally, we noted isolated locations where the side plates had shifted and had been re-fastened into the wall, leaving open holes for water intrusion. The condition of the side plates caused the typical condition of loose top and bottom rails at the balconies. **BECI recommends that the corroded fasteners be replaced with stainless steel fasteners and the holes be sealed within the next year.** The current condition the isolated rusted side plates makes them susceptible to further damaged and deterioration (Reference Photo Exhibit Nos. 21 through 24).

Photo 22
West Elevation – Private Balconies – Floor 3 – View of corroded side plate fasteners – Isolated.

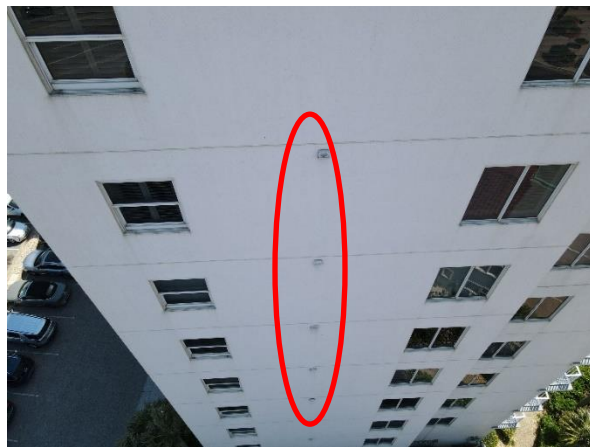
Photo 20
North Elevation – Overall View showing broken dryer vents – Typical.

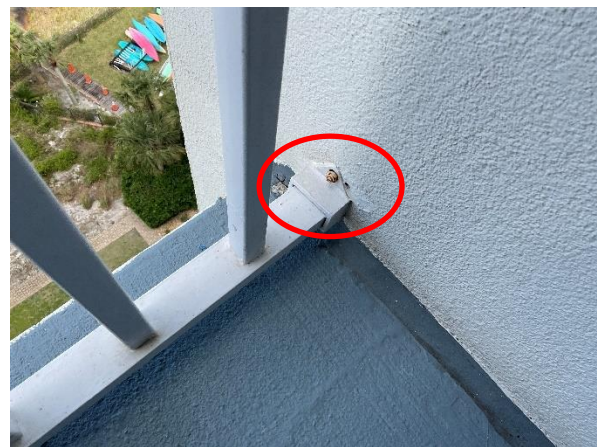
Photo 23
West Elevation – Private Balconies – Floor 10 – View of hole behind side plate fastener – Isolated.

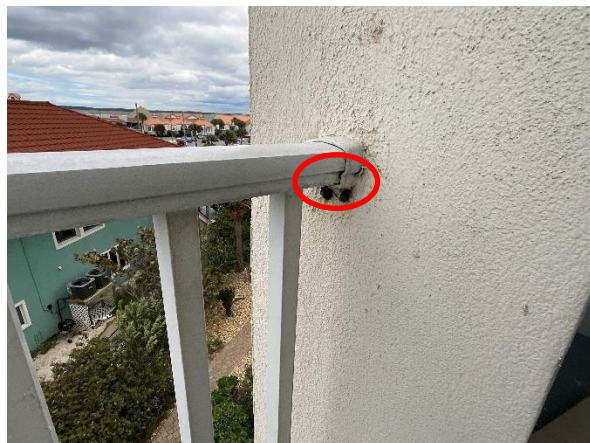
Photo 21
West Elevation – Private Balconies – Floor 3 – View of corroded side plate fasteners – Isolated.

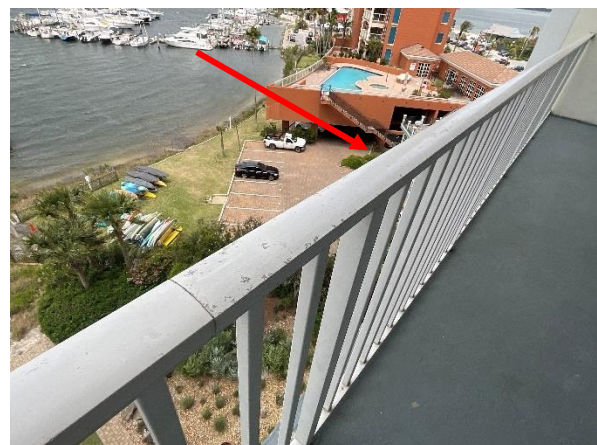
Photo 24
West Elevation – Private Balconies – Floor 6 – View of loose top rail – Typical.
